MITSUBISHI Q2ASCPU Q2ASCPU-S1 Q2ASHCPU Q2ASHCPU-S1

User's Manual (Hardware)

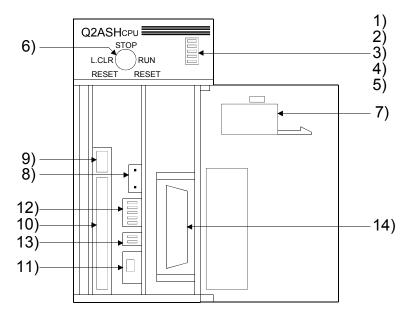
Illustration of the module with the front cover open

No.	Name	Application		
1)	RUN LED	 This LED indicates the CPU module operating condition. Lit :Operating with the RUN/STOP key switch set to RUN or STEP-RUN. Off :Stopped with the RUN/STOP key switch set to STOP, PAUSE, or STEP-RUN. Or, the CPU module has detected the error that would cause the operation to stop. Flash :The RUN/STOP key switch has been set from STOP to RUN after the program was written in stop mode. The CPU module is not in RUN mode. To engage the CPU module in RUN mode, set the RUN/STOP key switch to RUN, STOP, the RUN. Alternatively, reset the module using the key switch.

7)	Battery (A6BAT)	Backup battery to be used for the internal RAM and the power failure compensation function.	
8)	Battery connector pin	Used to connect the battery lead wire. (The lead wire is removed from the connector at shipment in order to prevent battery consumption.)

This section describes the name and setting of each part of the module.

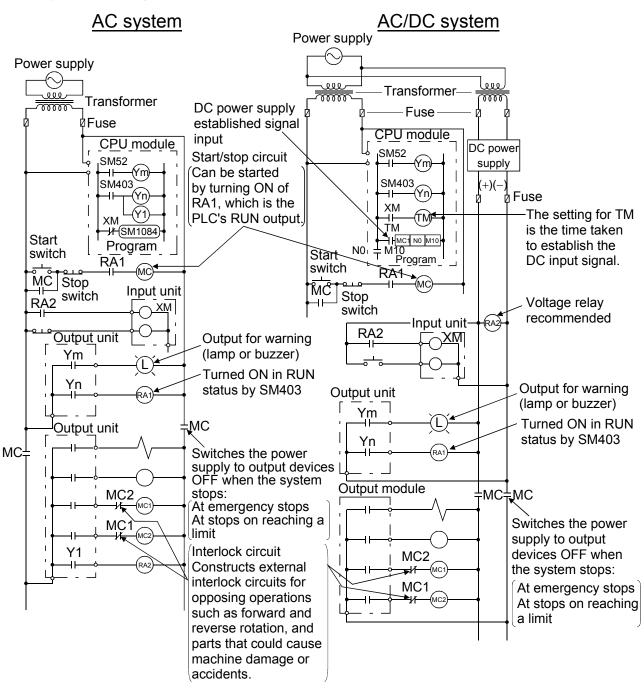
(1) System design circuit example

The procedures used to switch on the power supply are indicated below.

AC system

An example of system design, which is based on fail-safe concept, is provided on the next page.

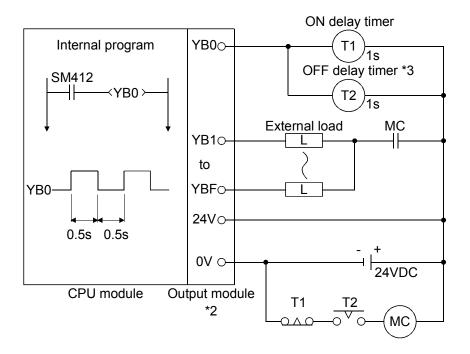
*1: The output module for fail-safe purpose should be mounted on the last slot of the system. (YB0 to YBF in the above system.)

- *2: Since YB0 turns ON and OFF alternatively at 0.5 second intervals, use a contactless output module (a transistor is used in the above example).
- *3: If an offdelay timer (especially miniature timer) is not available, construct the failsafe circuit using an ondelay timer shown on the next page.

(2) Fail-safe measures to cover the possibility of PLC failure Problems with a CPU module and memory can be detected by the self diagnostics function. However, problems with I/O control area may not be detected by the CPU module.

Though Mitsubishi PLCs are manufactured under strict quality control, they may fail or malfunction due to unspecified reasons. To prevent the whole system failure, machine breakdown, and accidents, build a fail-safe circuit outside the PLC.
